Manhole Inspection Summary

Manhole # S25E__052MH

Location Address: **125 CARROLTON AVE**

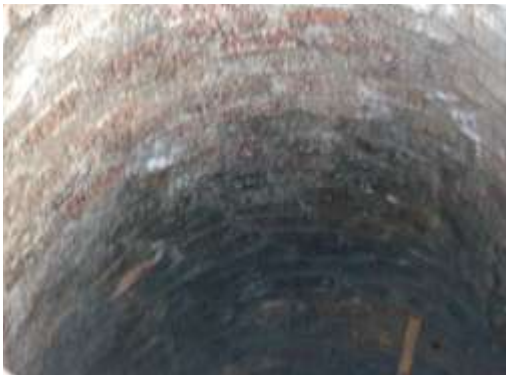
Defect 2

Infiltration: ☐ None ☐ Joint ☐ Cracks ☐ Mortar ☐ Roots ☒ Wall

INFILTRATION OF CORBEL

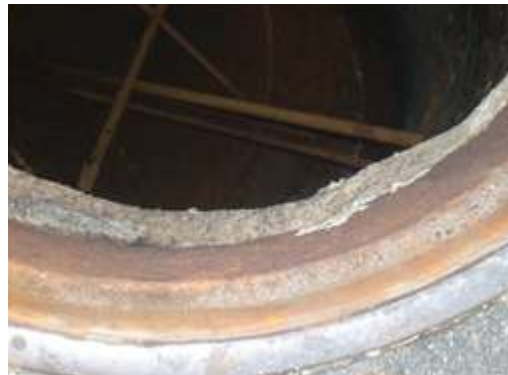
Defect 3

Offset: **1** (in.)

FRAME OFFSET

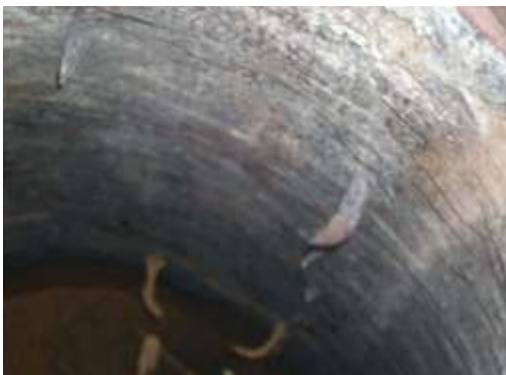
Defect 1

Count: **0** Missing: **5** ☐ Corroded

ALL MISSING STEPS

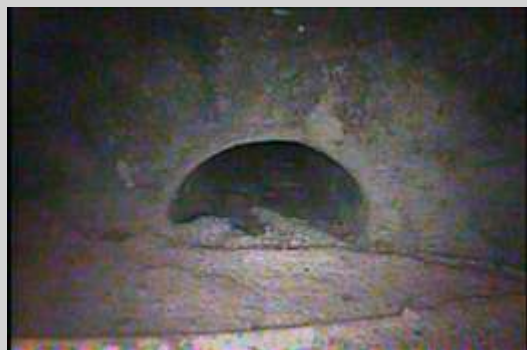
12 O'Clock Outflow

Deposits: ☐ None ☒ **Mud** ☐ Sludge ☐ Debris ☐ Grease

Silt Depth: **2** (in.) Deposits Extent: **Light**
